# Residential Inspection Report

Gem of The Hills Home Solutions, LLC  
Clermont, FL 34711

Sample report

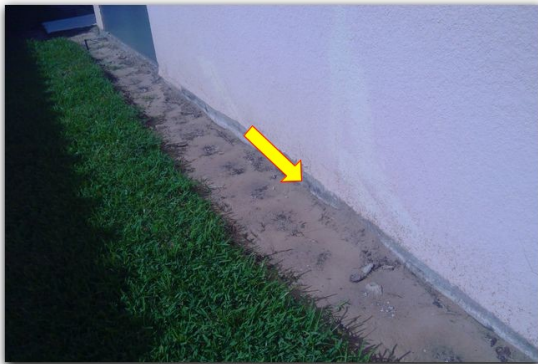
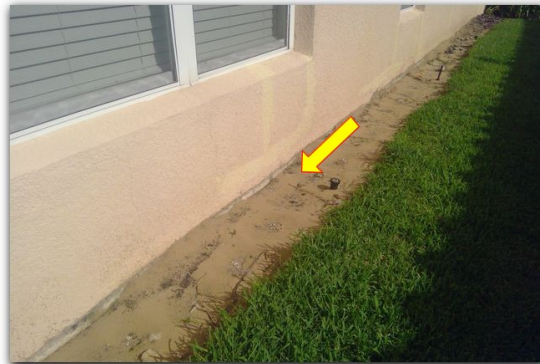
## 1.2 FOUNDATION, BASEMENT AND CRAWLSPACE

Comments: INSPECTED-defective

Foundation is becoming exposed due to the wash away of ground near home. This is being caused by the lack of gutters. Recommend gutters be attached to home to help prevent further washout.

- \* Foundation is becoming exposed due to the wash away of ground near home. This is being caused by the lack of gutters. Recommend gutters be attached to home to help prevent further washout.

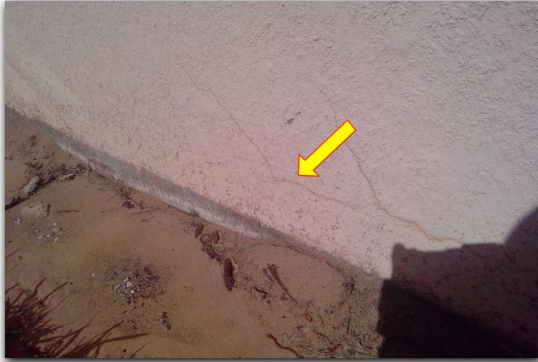
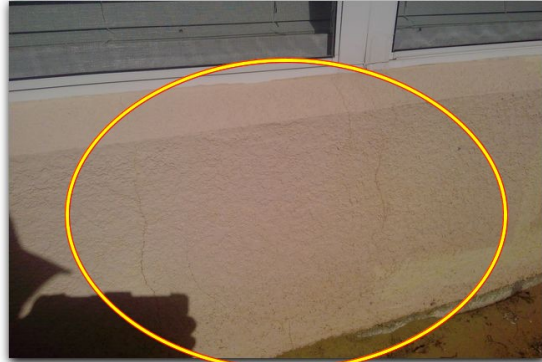
## 2.2 WALL CLADDING

Comments: INSPECTED-defective

Stucco cracks are present throughout exterior. Stucco cracks are a result of typical shrinkage and setting and are not considered a structural defect. However, all stucco cracks require sealing to prevent water intrusions. Water intrusions will exasperate conditions and cause additional failures and damage in the future.

- \* Stucco cracks are present throughout exterior. Stucco cracks are a result of typical shrinkage and setting and are not considered a structural defect. However, all stucco cracks require sealing to prevent water intrusions. Water intrusions will exasperate conditions and cause additional failures and damage in the future.
- \* Exterior paint appears to beyond its serviceable life expectancy. Recommend repainting as soon as possible.
- \* Exterior paint appears to beyond its serviceable life expectancy. Recommend repainting as soon as possible.

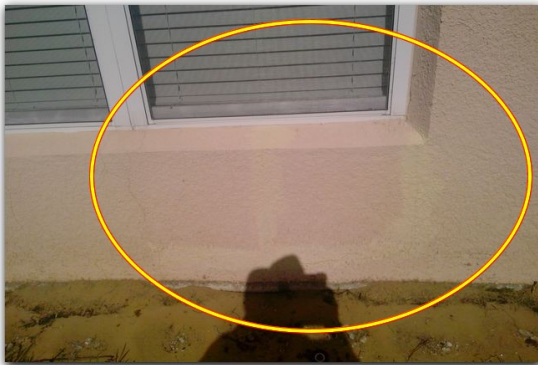
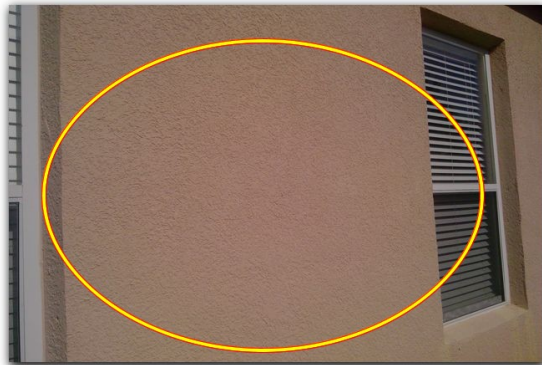
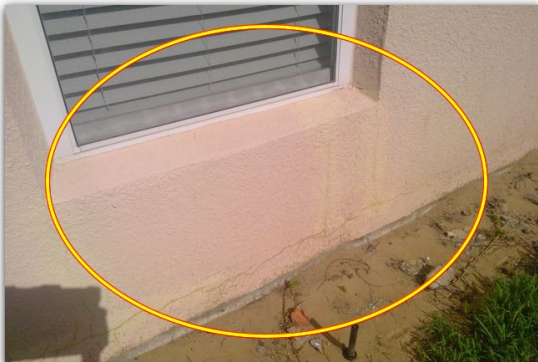
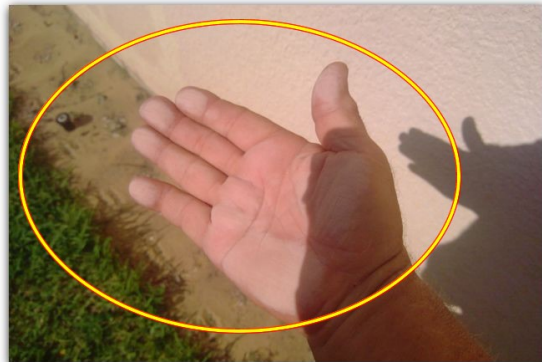
Exterior paint appears to beyond its serviceable life expectancy. Recommend repainting as soon as possible.

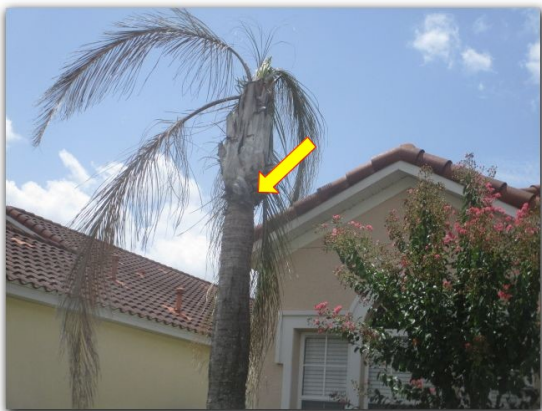
## 2.8 VEGITATION

Comments: INSPECTED-defective

Palm tree in front yard is dead and in need of removal.

- \* Palm tree in front yard is dead and in need of removal.

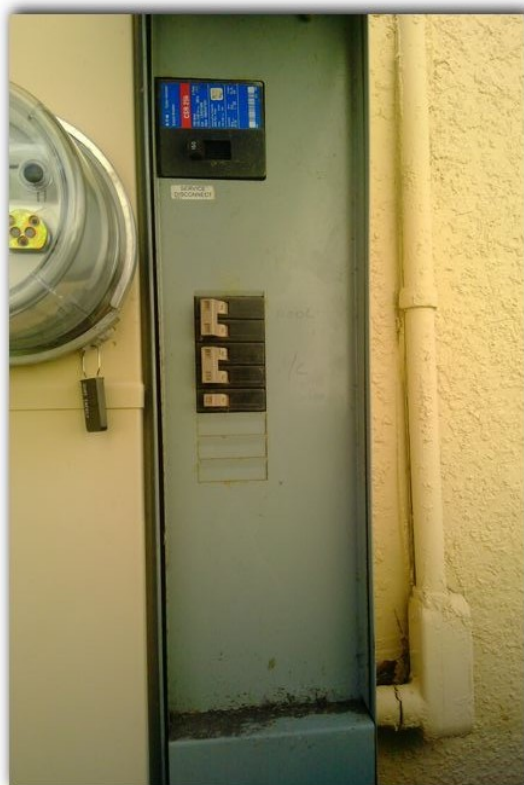
Disconnect with cover

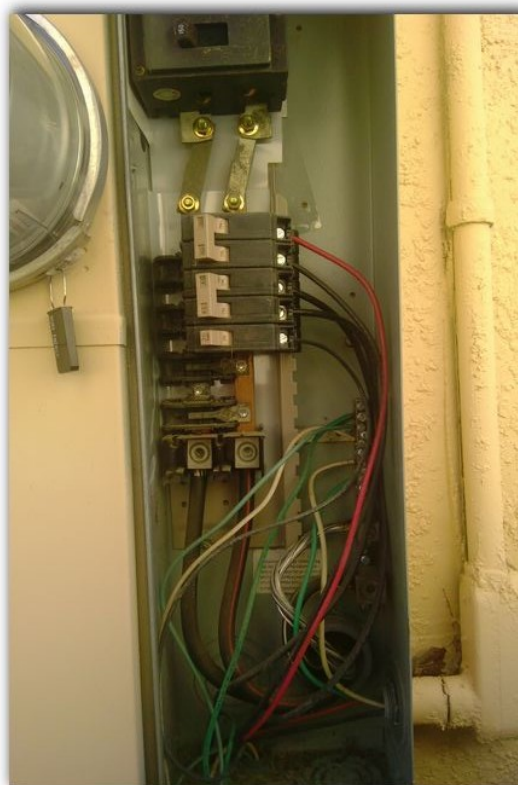
Disconnect without Cover

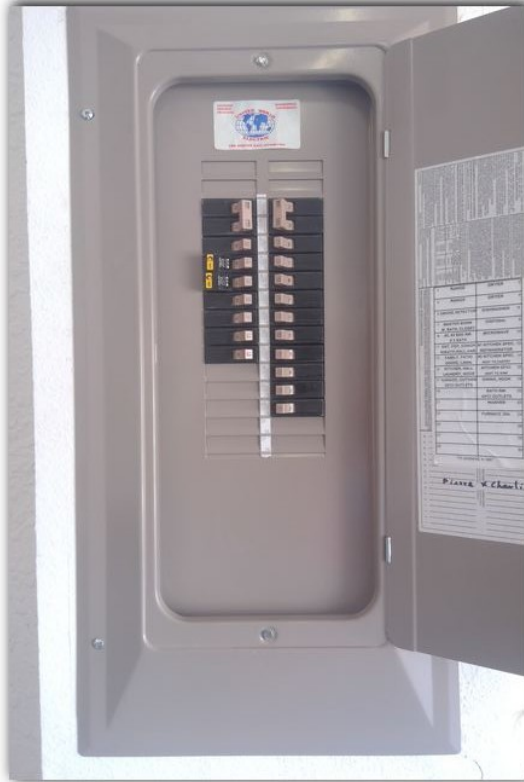
**Distribution Panel W/Cover**

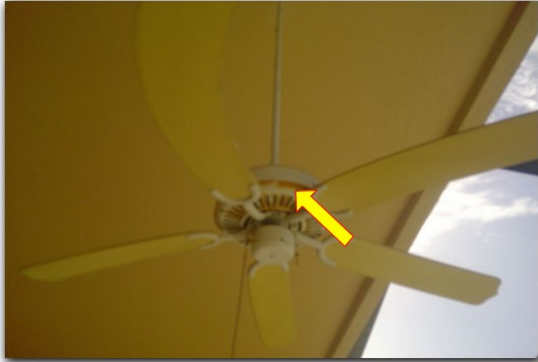
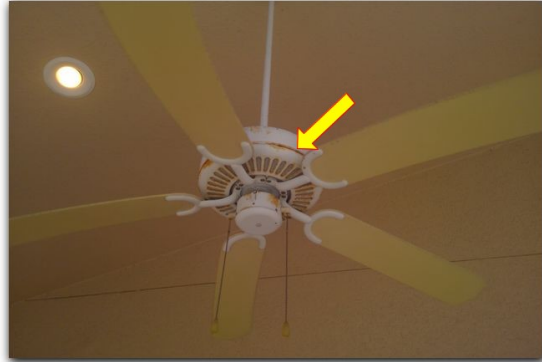
Comments: INSPECTED-defective

Although still operational ceiling fans on rear patio are corroded and in need of repair.

\* Although still operational ceiling fans on rear patio are corroded and in need of repair.

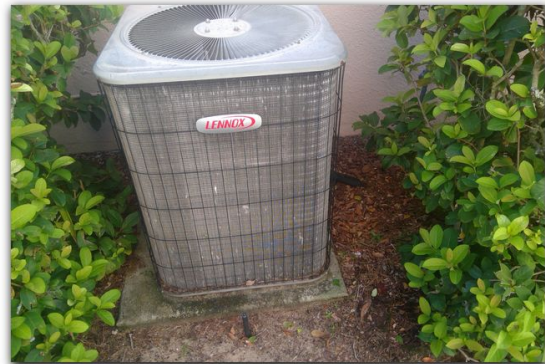
**Mfg Date of Compressor 2005**

**Overall Pic of Compressor**

Note: The typical life expectancy of the average system is 12-16 years. However, many homeowners will replace their systems after 10 years to achieve a higher efficiency rating. If you system is over 12 years it should be considered at the end of its life expectancy and replaced.

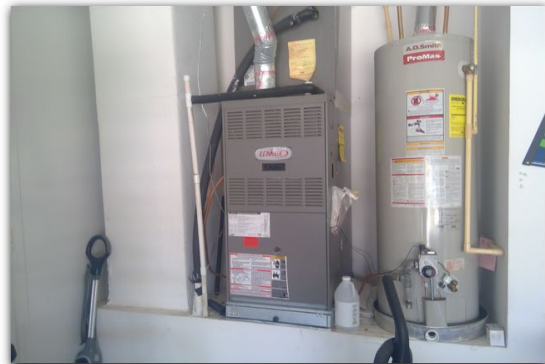
**Mfg Date of Air Handler 2005**

**Overall Pic of Air Handler**

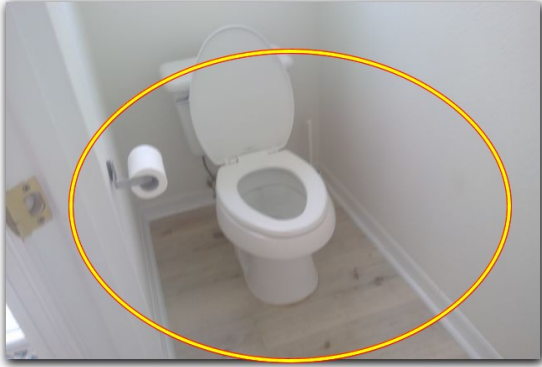
Comments: INSPECTED-defective

Water closet (toilet) is loose to floor in master bathroom. Mold or further damage may be present in areas that are not visible to inspector. Requires further evaluation and repair by a licensed contractor.

- \* Water closet (toilet) is loose to floor in master bathroom. Mold or further damage may be present in areas that are not visible to inspector. Requires further evaluation and repair by a licensed contractor.
